**Company Name:** Hart Close (Wootton Bassett) RTM Company Limited

**Inspector Name:** K. Zak

**Inspection Date:** 17 November 2025

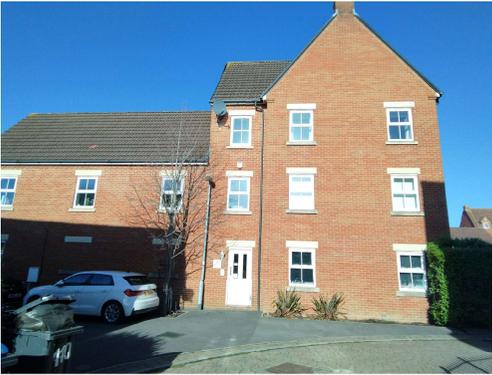
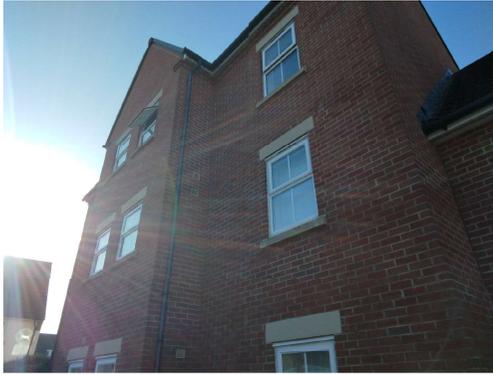
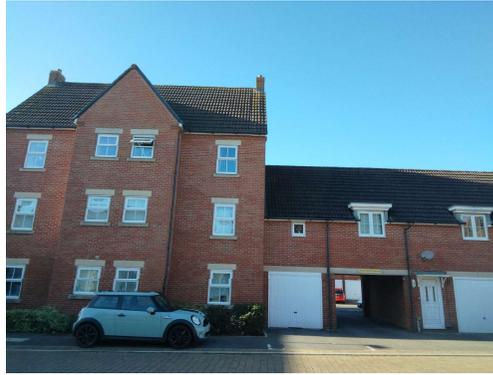
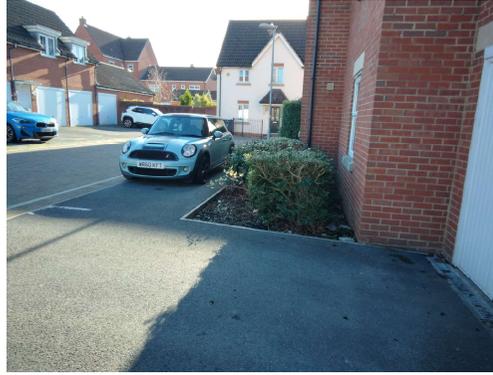
Exterior Structure (The Building)	Guttering (Gutters and Fascia)	Roofing (Tiles and Cladding)	Communal Grounds (Gardens and Common Areas)

External Inspection	Acceptable	Not Acceptable	N/A	Comments	Action
<b>Exterior Structure</b> (The Building)	✓			Visual inspection of the exterior walls showed no concerns.	None
<b>Guttering</b> (Gutters and Fascia)	✓			No signs of leaks or water overflow; fascia boards also in good condition.	None
<b>Roofing</b> (Tiles and Cladding)	✓			Roofing inspected from ground level – no signs of damage noted.	None
<b>Communal Grounds</b> (Gardens and Common Areas)	✓			Communal grounds were tidy, well-kept.	None
<b>Bin Store</b> (Waste Disposal Areas)	✓			Bin area was clean and organised, with all bins properly stored.	None
<b>Car Park</b> (Vehicle Parking)	✓			Parking area is in good visual and functional condition.	None
<b>Bike Store</b> (Bicycle Areas)					None
<b>Additional Comments</b>					None
