# COMBINED FIRE AND HEALTH & SAFETY RISK ASSESSMENT.

Address of premises:	6-12 Hart Close Royal Wootton Bassett SN4 7FN
Responsible Person:	Hart Close (Wootton Bassett) RTM Company Limited
Duty Holder:	Block Management Limited
Person(s) consulted:	No occupier or other relevant person available to consult.
Assessor:	Rob Cockburn
Report validated by:	John Godfrey, GIFireE.
Date of fire risk assessment:	4 <sup>th</sup> November 2025
Date of previous fire risk assessment:	September 2023
Suggested date for review:	November 2026

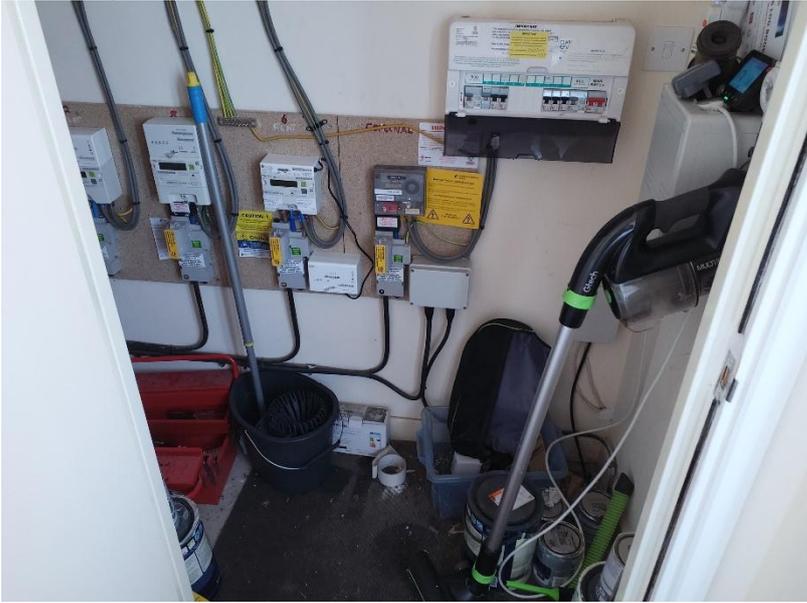
Item	Recommendation	Priority	Timescale
01	<p>Housekeeping was found to be of a poor standard at the time of this assessment with the electrical intake cupboard being used for storage. It is recommended that the client arrange for the electrical intake cupboard to be cleared as a priority and all residents reminded of the importance of maintaining sterile communal areas and escape routes.</p>

2	B

Ongoing action required

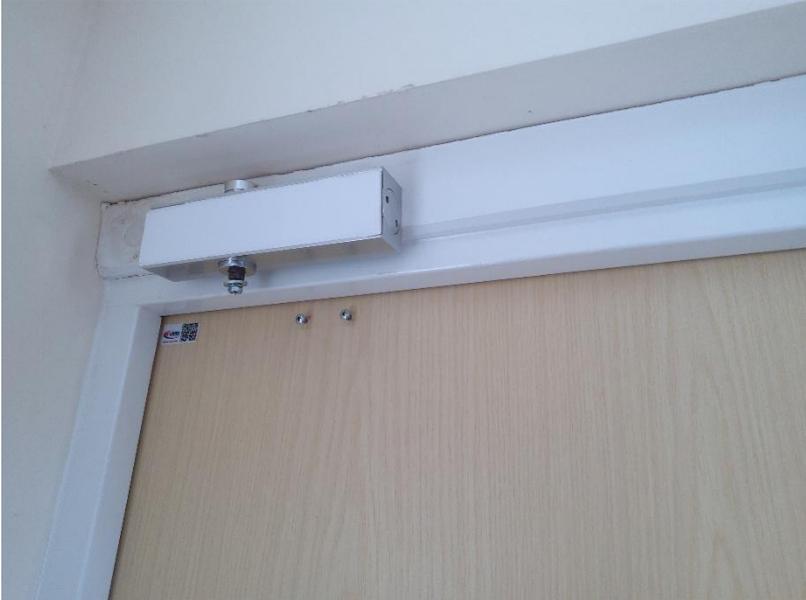
<p>02</p>	<p>As per section 33.2 of Fire Safety in Purpose-Built Block of Flats a type 1 fire risk assessment requires us to conduct a fire door survey on a sample of flat front doors. No resident was available for the survey however the following deficiency was noted:</p> <ul style="list-style-type: none"> <li>Flat 12's closer appears to be disconnected</li> </ul> <p>It is essential that each flat entrance door is a suitable fire door, providing a minimum of thirty minutes fire resistance, hung on three grade 13 hinges and having a functioning self-closing device fitted that positively closes the door on the latch, together with smoke and intumescent seals. It is recommended therefore that the RP instruct a suitably qualified and competent contractor to conduct a fire door inspection to all flat entrance doors providing advice on suitability as per "Fire Resisting Doors – 62-12 to 62.17" of Fire Safety in Purpose-Built Block of Flats. Any shortcomings identified by this inspection should be addressed as a priority by upgrading or replacing the door.</p> <p>Flat entrance doors, communal area doors, the seals and the self-closing devices should then be subjected to an annual inspection and maintenance schedule.</p>

<p>3</p>	<p>B</p>	<p>Ongoing action required DH has informed owner. Inspection carried out in accordance with current legislation.</p>
